### M E M O R A N D U M

DATE: April 22, 1986  
TO: Erin Moran, RPM, USEPA, Region V  
FROM: Pat Petrella, Ecology and Environment, Inc., FIT  
SUBJECT: Ohio/R05-8512-06  
Elyria/Chemical Recovery Systems  
OHD057001810

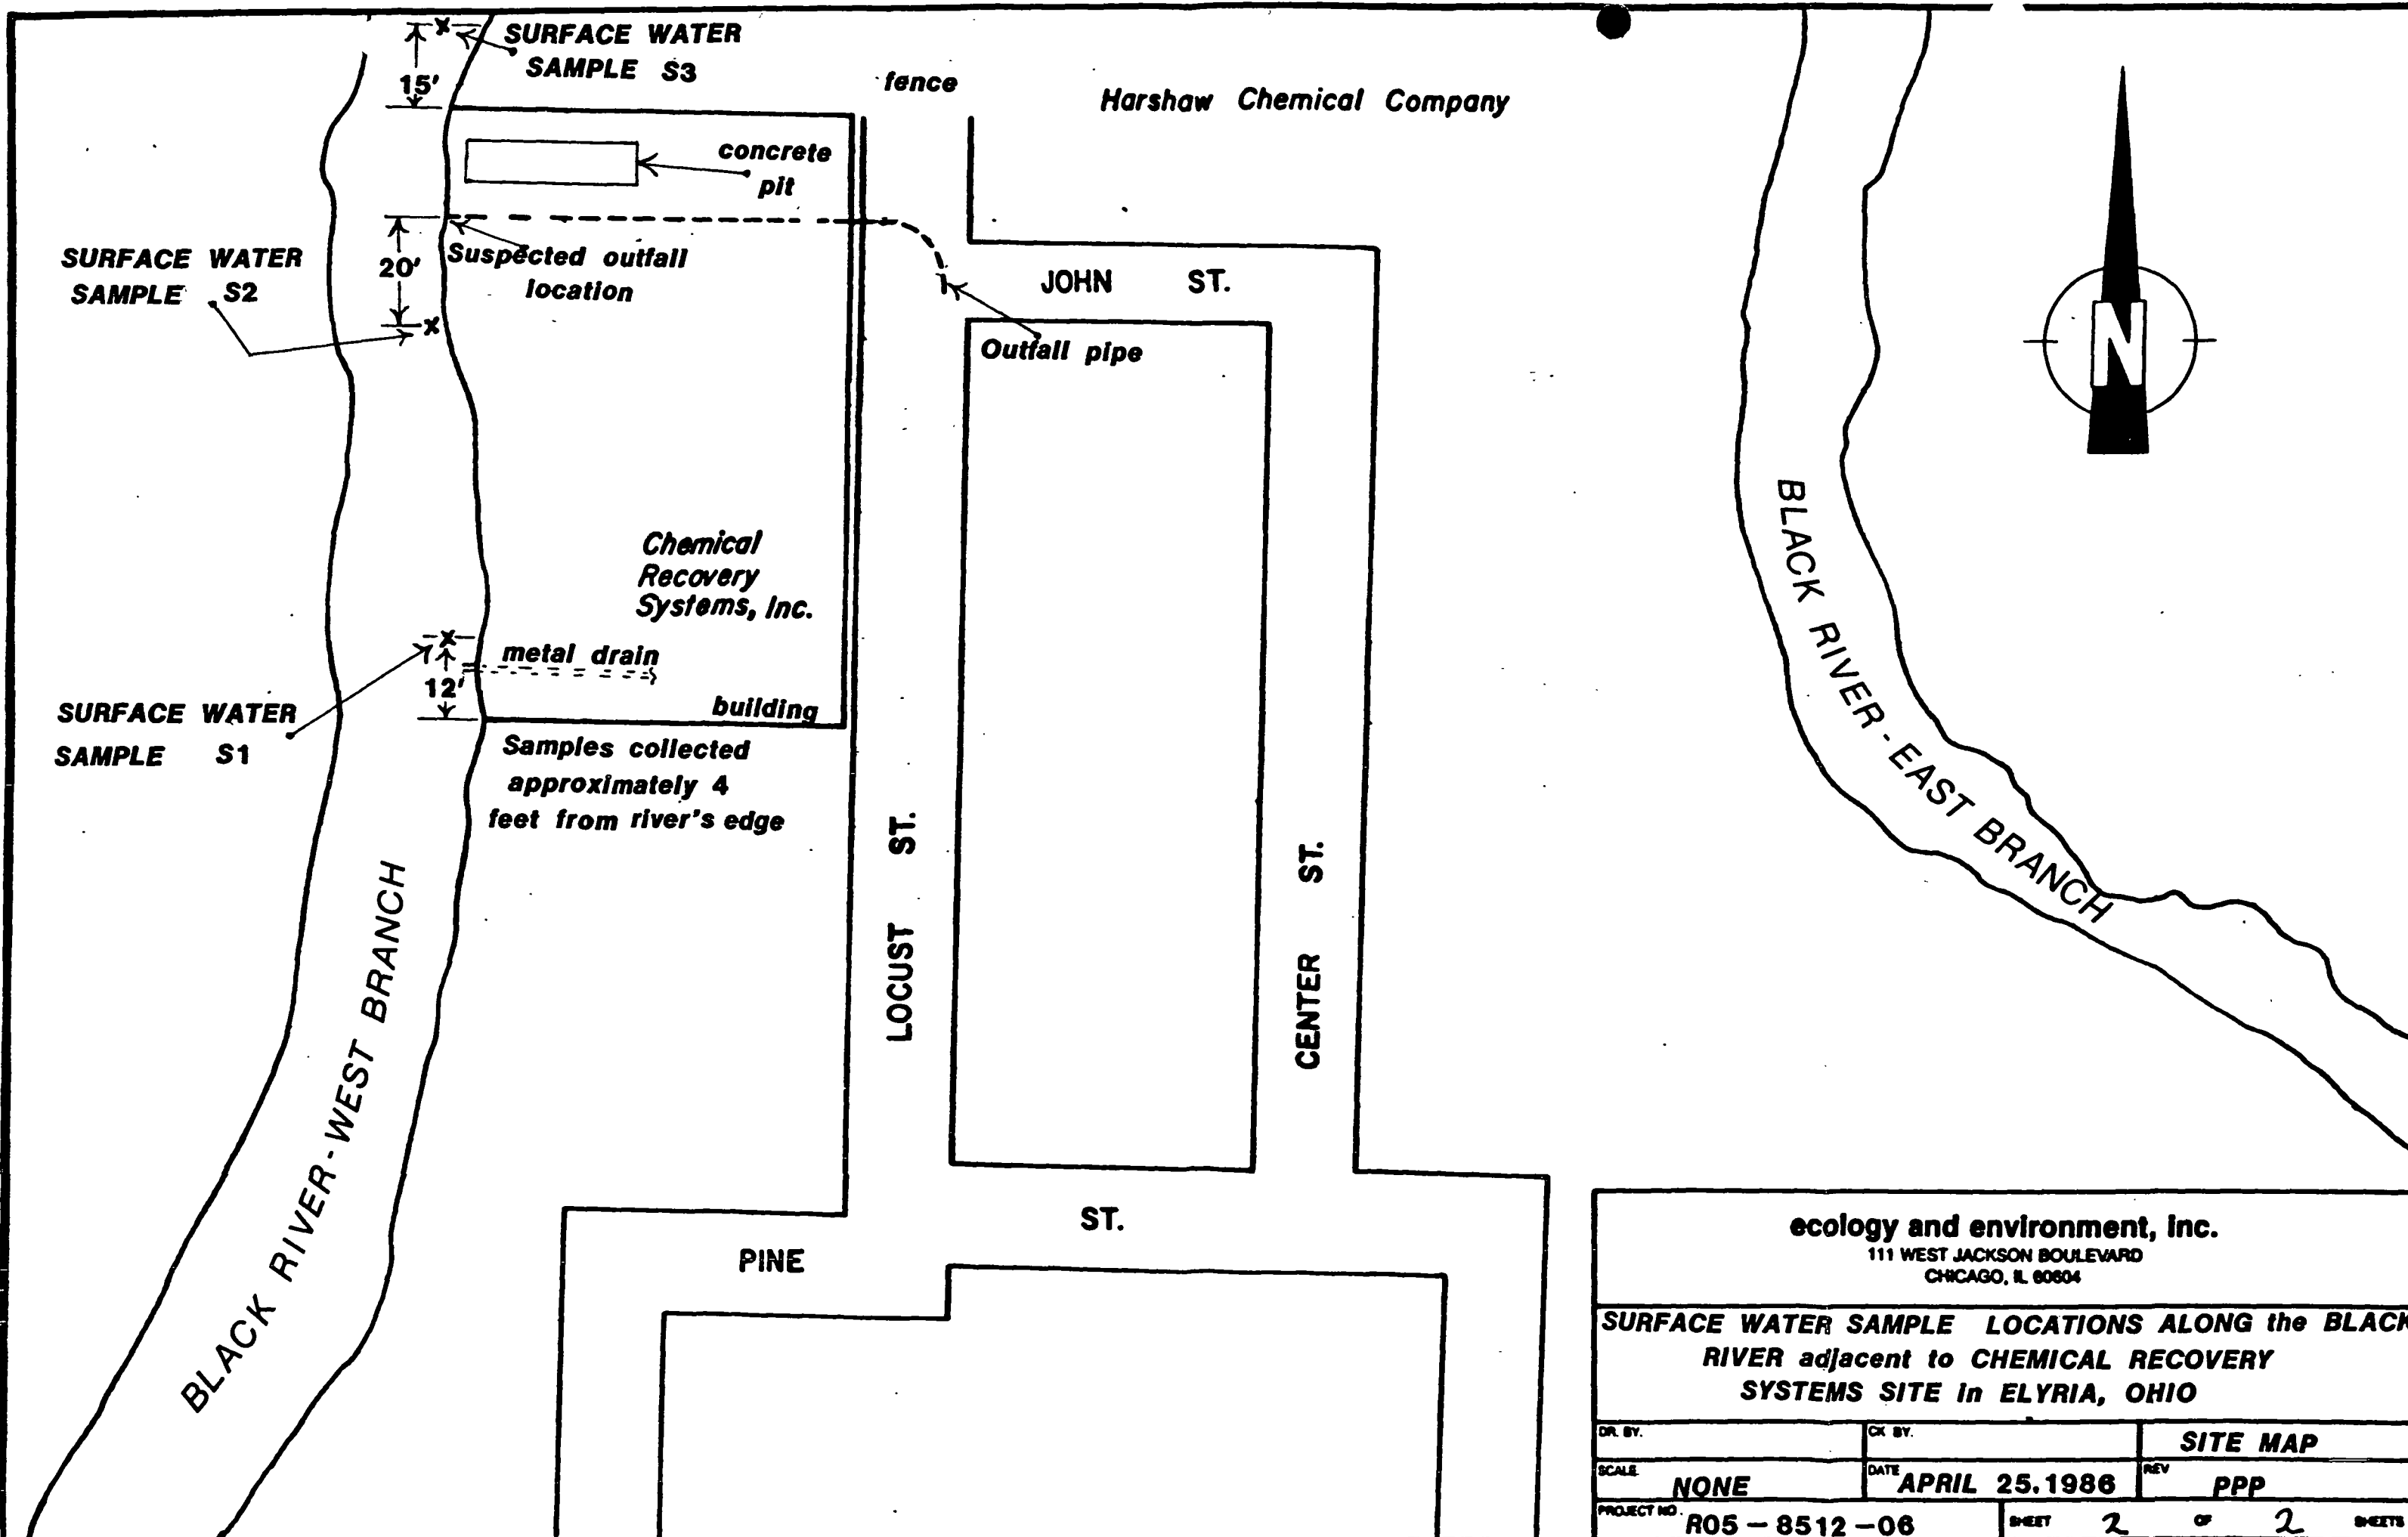
The samples S1, S2, and S3 were collected from three distinct sampling points along the river upstream and downstream of CRS and at an outfall discharge from CRS (See Figure 2). All sample locations were on the east side of the east branch of the Black River. Sample

S1 is the downstream sample, S2 is the outfall sample, and S3, the upstream sample. Sample S1 was collected approximately 12 feet upstream of the site's southern fence line because there was no place to stand along the river's edge, further downstream, to collect the sample. Sample S2, the outfall sample, was collected downstream of a point suspected of being the outfall location sampled by CLOW, Inc. in November, 1985. This alternate location was chosen since the outfall pipe could not be found. This location was chosen based on the following information:

- o Approximately 20' upstream of the sampling point was a cove recessed into the river bank that indicated where an outfall may have been active at one time. There was no flow from this location into the river.
- o Broken drain tile was noted in the cove area. A report by Ecology and Environment, Inc. (E&E) dated April 26, 1982 indicates that the outfall in question was the drain tile.
- o The actual distance from the north site boundary to the center of the cove was approximately that distance measured by E&E during the hydrogeologic study.

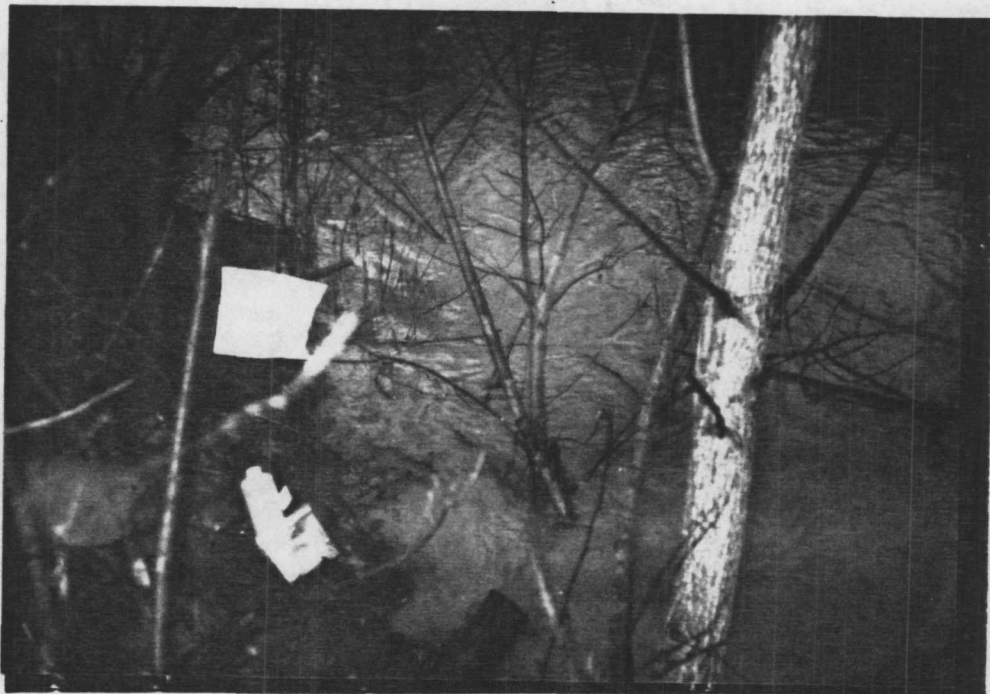
SW 2 <sup>NEAR</sup> Outfall

DESCRIPTION: Far Away shot of sample location on the River.DATE 2-5-86TIME 4:20 A.M. (P.M.)

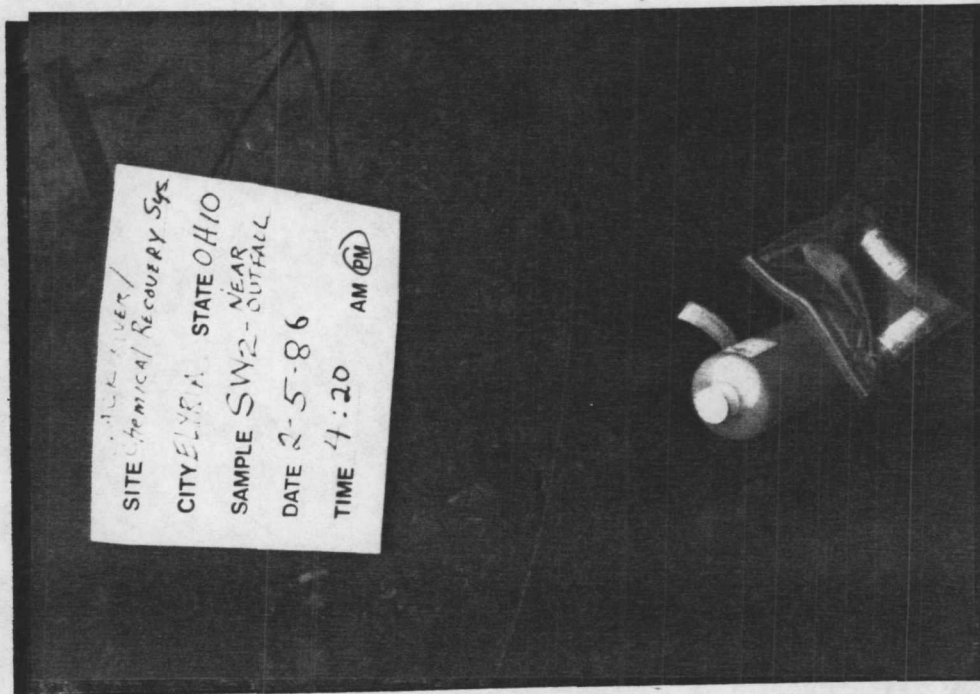
SW 2 <sup>NEAR</sup> Outfall

DESCRIPTION: Close up shot of sample location AND ID card.

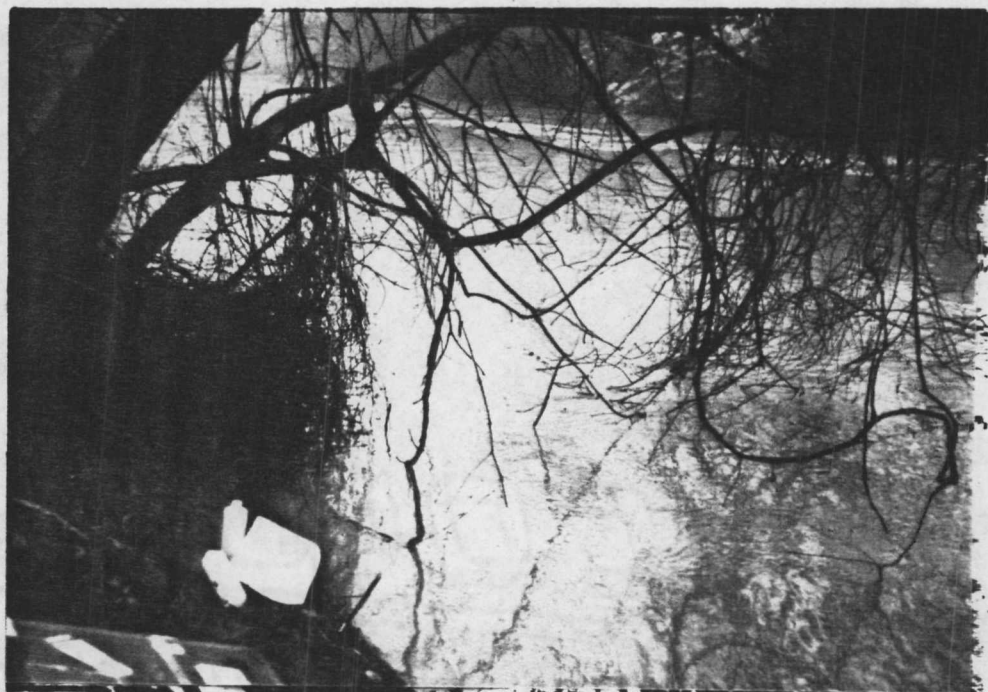
SW-1 (Downstream)

DESCRIPTION: Looking downstream on Black River, East Branch at sample location & surrounding area.

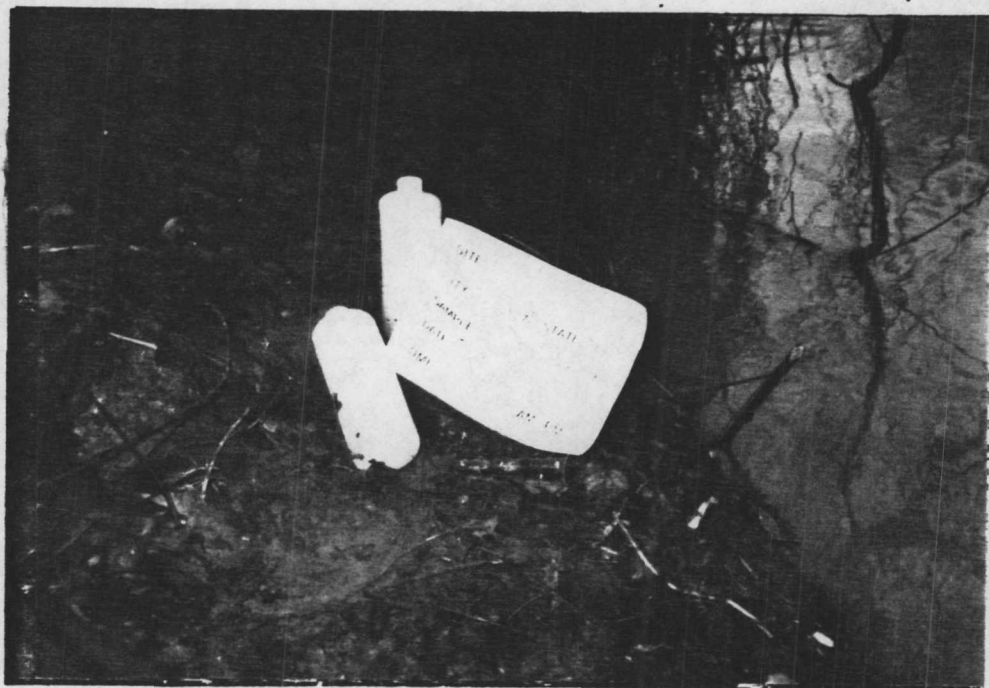
SW-1 (Downstream)

DESCRIPTION: Looking downstream at location of sample collection, a close up view.

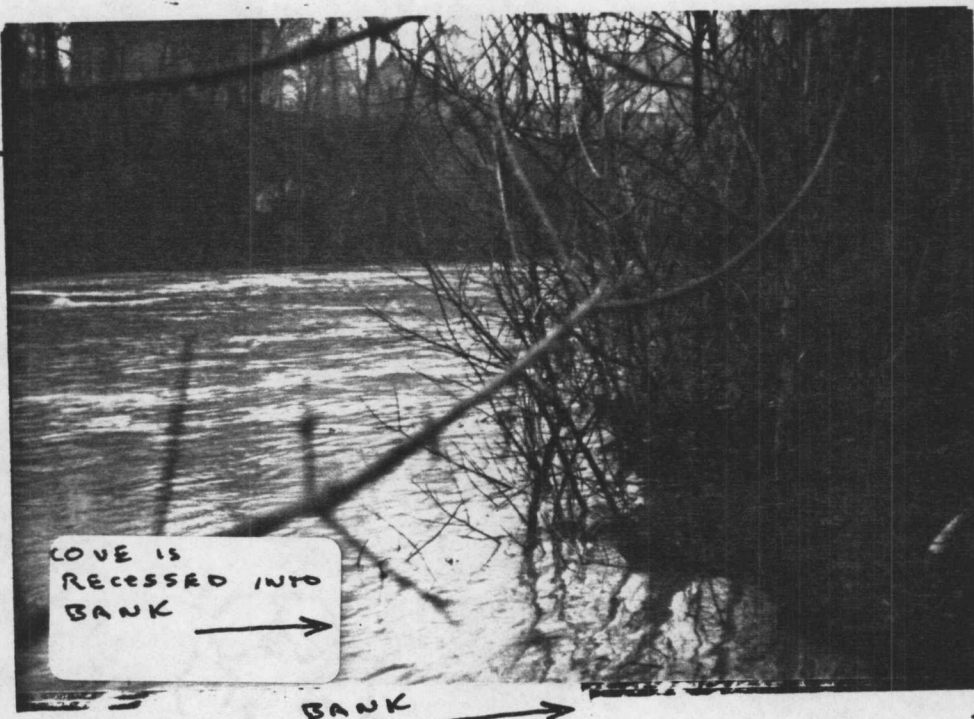
DESCRIPTION: Looking upstream from cove area where accident  
was suspected of existing. Cove area not shown but is  
to the right of picture.

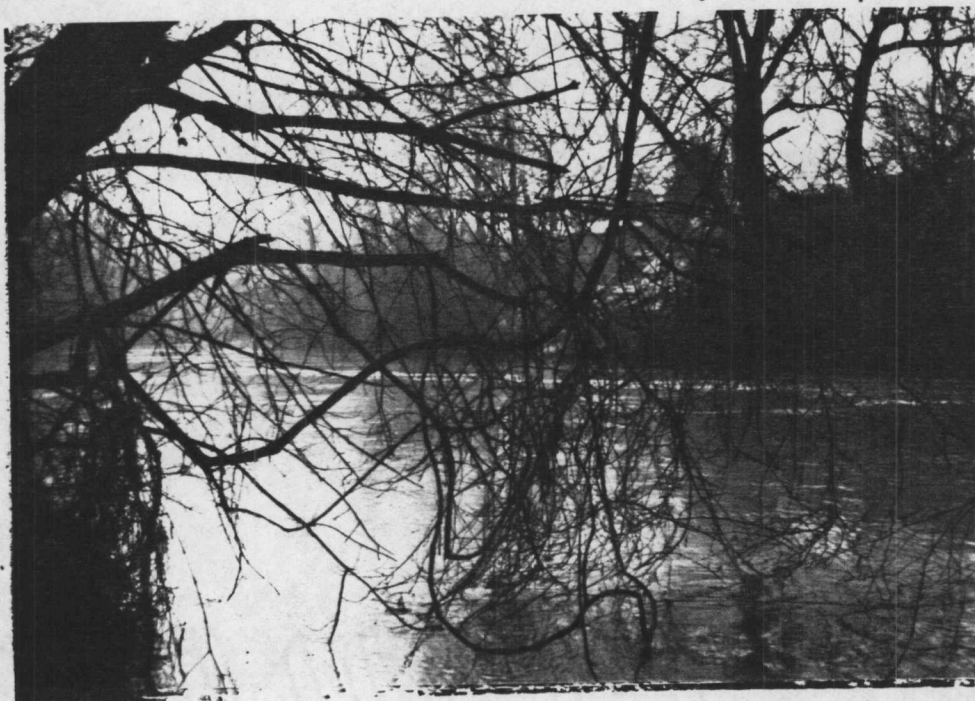
DESCRIPTION: Looking Downstream from Cove area on River's  
edge. Steep sloped walls along River shown in background

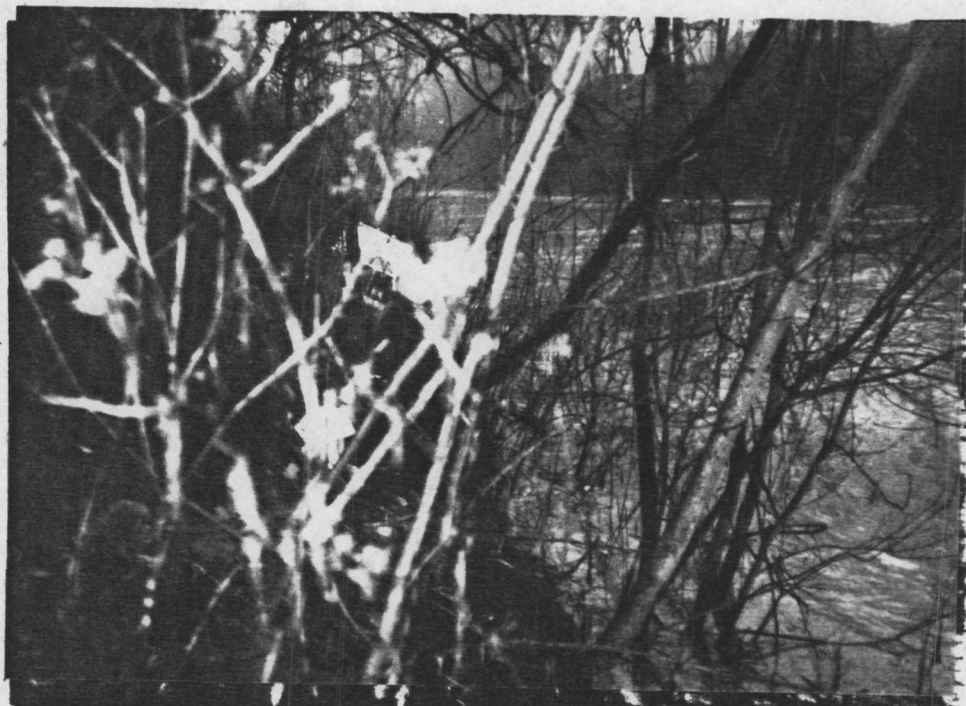
DESCRIPTION: Looking downstream along bank of River. Note the heavy vegetation and limited walking room to collect samples.

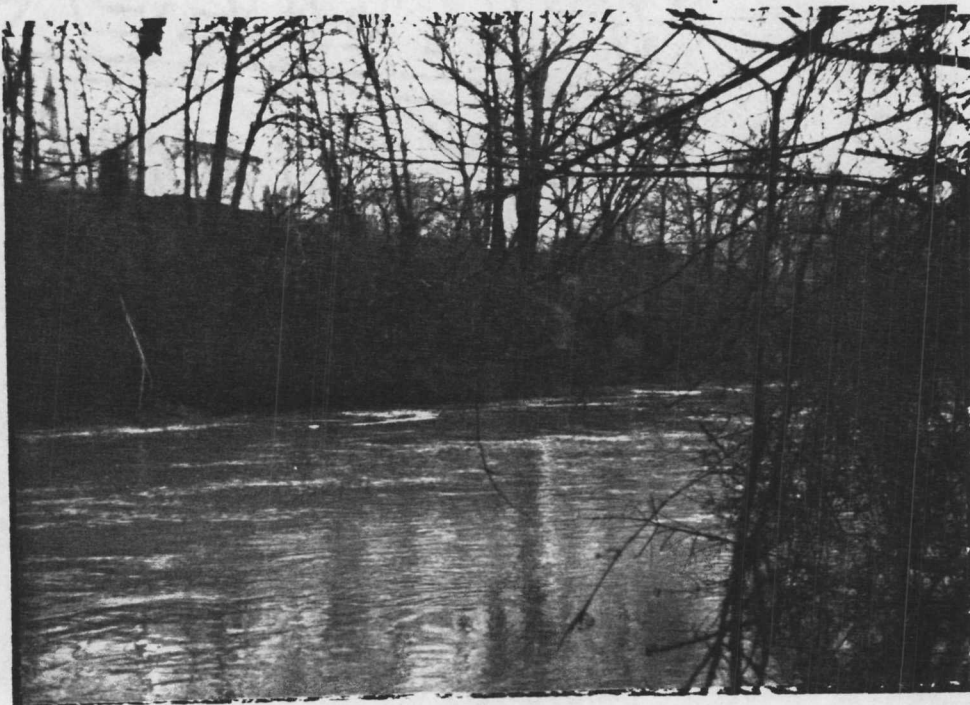
DESCRIPTION: Looking upstream from cone area indicating River height and slopes along N. end of site on West side of River.
